ES-24.30	<p>HUDSON PRODUCTS CORPORATION <i>Fan Engineering Standards</i></p> <p>Title: Field Inspection Guidelines Hudson Tuf-Lite® (Black), Tuf-Lite II® (White, previously Blue) And Tuf-Lite III® (White, previously Green) Blades</p>	Page 1 of 6
-----------------	---	-------------

1. DEFINITIONS

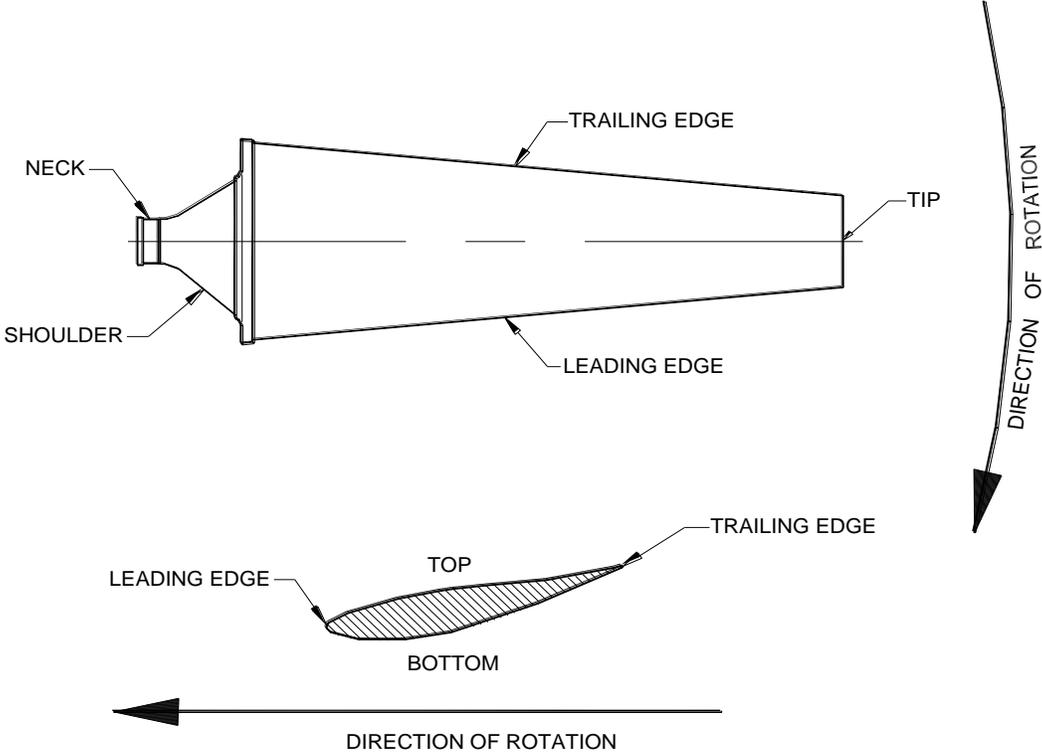
- 1.1 The **leading edge** is the rounded portion of the blade.
- 1.2 The **trailing edge** is the thin section of the blade.
- 1.3 The **neck** is the cylindrical area under the blade clamps.
- 1.4 The **shoulders** are the tapered transition area from the neck to the widest part of the blade.
